## THE IMPACT OF CLIMATE CHANGES ON COSTAL ARCHAEOLOGICAL SITE CASE STUDY AL- BURULLUS LIGHTHOUSE

Dalia Shebl <sup>a,\*</sup>

<sup>a</sup> Architecture Department, Faculty of Engineering, Kafr Elsheikh University, Egypt

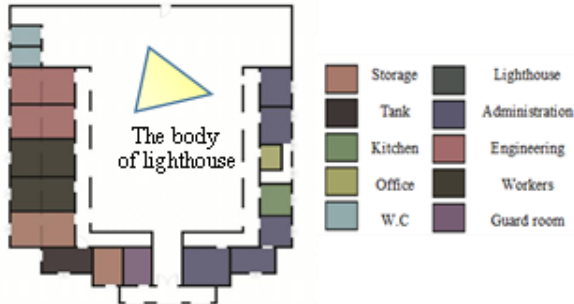
The site is approximately a square shape, about 19.25x18.65m and in the middle of site located the body of the lighthouse surrounded by a group of rooms on three sides, as in Fig. 2.

Fig. 2. Shows the plan of the site and its collected elevation Researcher 2023.

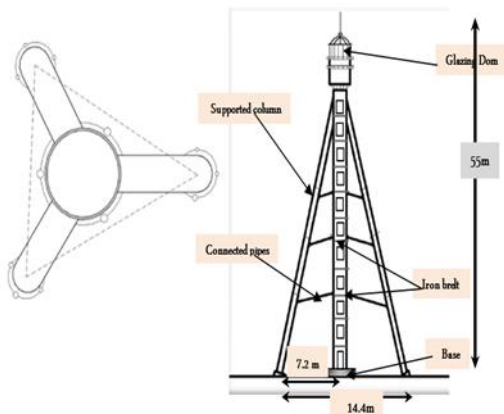
The structure of the lighthouse consists of 3 parts (base - body - dome). It is made of solid iron as a hollow cylindrical column with a 3.80 m diameter and a circumference of 5.80 m (Saber, 2015). The column has 19 cast iron belts, the distance between the lighthouse column and the supporting column is about 7.20 m. and the distance between the two supported columns is about 14.4 m. Its weight about 40 tons as Fig. 3.

Fig. 3. The Elevation of lighthouse and its components Documented by Researcher 2023.

- There are three pillars (supports) installed on 6 iron springs around the lighthouse to help the flexibility and inclination when the wind is strong, as it tilts in each direction from 8-12cm.
- The door of the lighthouse opens on the northern side as a form of quarter-circle, where leads to the stairs that ascend to the top. There are rectangular openings in the corners of the tower to light the stairs with a frame of wood closed with transparent glass as Fig. 4.
- At the top of the lighthouse there is an iron compass to determine the directions, and a glass part with

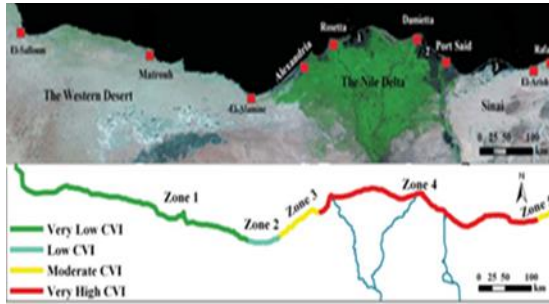
Fig. 5. A satellite image showing the division of the coast line in Egypt into 5 parts and the most exposed places to severe erosion (Masria A.et al., 2014).

The coastal shore in Egypt extends for more than 1,000 km and is divided into three different geomorphological zones. The Western coastal zone, which constitutes 550 km of the Western Desert (known as the North Coast); The central region represents the coast of the Nile Delta with a length of 250 km. And the eastern costal region extends for a distance of 200 km to North Sinai. (Pirazzoli, 1991). The coastal line has been divided into 5 sections according to their exposure to erosion, where they find the most dangerous sites and the most vulnerable to coastal erosion as Fig. 5. The study focused on Zone 3 in the final parts of the River Nile branch (Rashid, Damietta and along Lake Burullus). Erosion rates in these sites exceeded 2 m/year in especially at the location of the head (Masria A.et al, 2014).

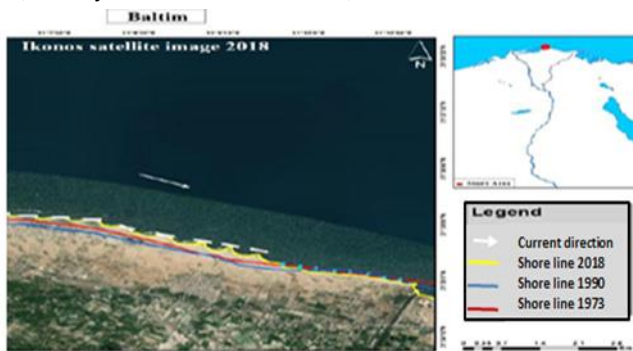
Fig. 6. Image monitored by GIS of the change of the central coast line during last 28 years. Source: Stanley, 2008

The Nile Delta is a part of the mid-coastal region where there are clearly human and natural stresses on it, and they are increasing with time. The coast of the Nile Delta has been designated as a vulnerable zone to a consequence of ongoing coastal processes and accelerated sea-level rise, and natural geographic low-lying deltas, in addition to human influences. And the action of the sand on the coast moves from the Nile as a result of dam construction in the river basin, as Fig. 6 (Stanley, 2005 & Ismail, 2010).

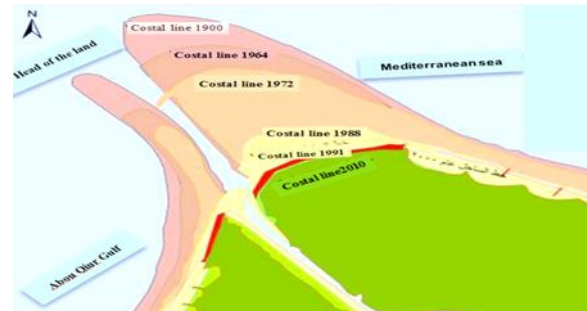
Fig. 7. monitoring the changes that occurred on the coastline from 1900 to 2010 Source: Ismail, 2010

erosion and accumulation from 1973 to 2018, an overlay of GIS layers was obtained with IKONOS images that were taken in 2018 as shown in (Salama et al, 2021) as Fig. 7 .

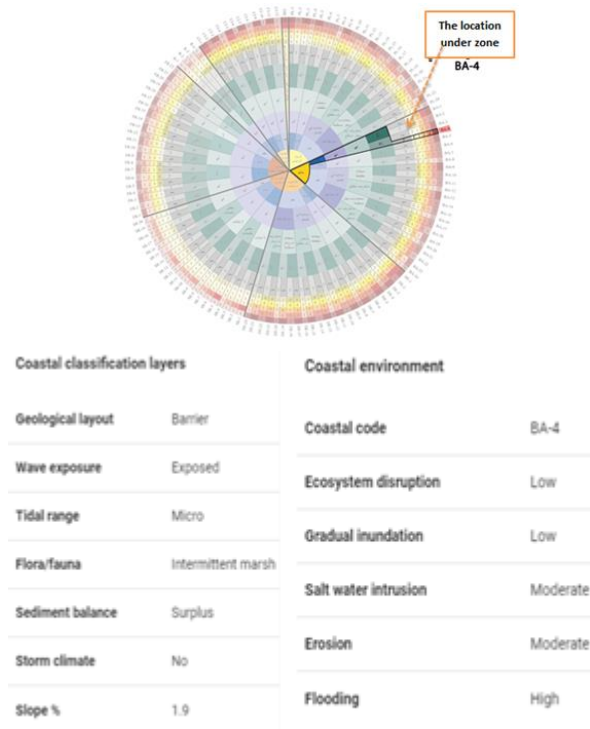
Fig. 8. The risk assessment degrees in the delta region - middle section coastal line in Al-burllus. Analysis by researcher from CHW application. <https://www.coastal hazardwheel.org/>

By recording the characteristics of the Mediterranean coastline using coastal hazard wheel app (CHW) where it is consider a simple technical tool that can be used in coastal areas and includes 131 general assessments of different coastal environments and a group of 655 sets assessments of risks, each one comes out to four different levels of risk (Appelquist, 2015) as Fig. 8. CHW facilitated analysis of a number of other inherent hazards including ecosystem disruption, gradual inundation, salt water intrusion, and flooding. CHW characterizes the coastal environment by considering geological layout, wave exposure, tidal range, flora and fauna, sediment balance and storm climate. CHW Application identified coastal erosion to present a high to very high influence on the Mediterranean coastline, with 45.7% of the coast exhibiting a low level of erosion hazard, 12.1% a moderate level, 12.6% a high level and 18.4%, a very high level of erosion hazard.

The risk assessment wheel has shown that more than one third of the coast is highly exposed to sea level rise, especially in the study area, the densely populated Nile Delta coast and highly exposed to sea level rise, which was formed from flat delta sediments with a length of 250 km along the Mediterranean Sea as a result The Nile River has been flooding since ancient times, and the water level data on the tidal range is between 16 and 88 cm and does not exceed 24 cm for monthly readings.... The maps and satellite data also show the main prominent parts located within the delta coast, which are subject to significant erosion. The sediment receives erosion of different degrees, as well as the absence of an engineered structure on the coast to disrupt the waves caused by long-shore sediment erosion in the study area.

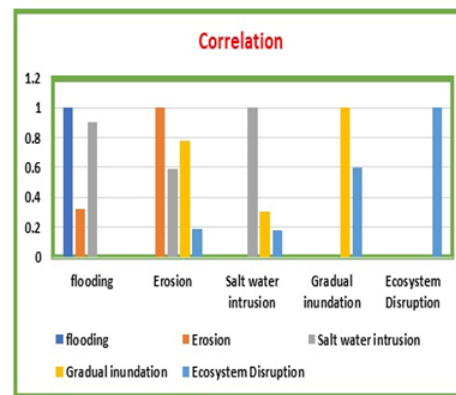
Correlation	flooding	Erosion	Salt water intrusion	Gradual inundation	Ecosystem Disruption
flooding	1				
Erosion	0.319838	1			
Salt water intrusion	0.904534	0.59238	1		
Gradual inundation	0	0.77675	0.301511345	1	
Ecosystem Disruption	0	0.18390	0.17978663	0.596284794	1

Fig. 10. The co-efficient of correlation between varouis enviromental variables

According to previous analysis , the Delta coastal line and the natural agents of climate that affect strongly on each other ( salt water , flooding , erosion, gradual inundation and ecosystem disruption) contribute in direct and indirect links of many phenomena appearing to the coastal shore and change its features. So the research used SPSS statics to analyze the different natural agents and found the co-efferent of correlation between environmental variables, where noticed that all variables moved in a positive direction and the results forward to record a high degree of correlation between salt water intrusion and both flooding and erosion and salt water intrusion and gradual inundation which means a danger agent and sever risk while the analysis clarify a Moderate correlation appeared in the relation between erosion and salt water intrusion and appeared a Low degree of correlation in the relation between flooding and erosion and the relation between salt water intrusion and gradual inundation and Ecosystem disruption as Fig. 10.

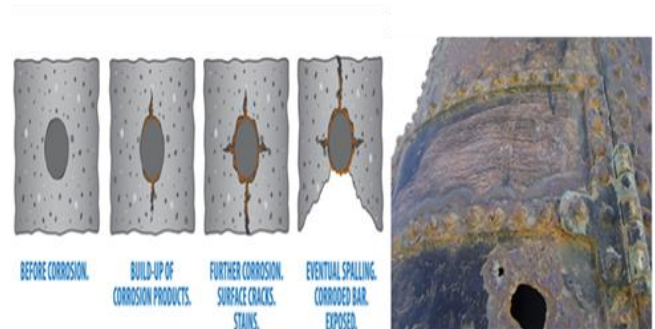
Fig. 12. Rust and corrosion stages in the section iron of lighthouse.

The lighthouse was subjected to many stages of neglect and deterioration over the course of its lifetime, as it was exposed to corrosion and rust and suffers from clogged pores and filling them with salt water and air immersed in brine that settled in the metal structure over the years. where consider the major cause of corrosion is chloride attack. it has entered the surface via the use of de-icing salts or from a chloride rich coastal environment as shown in Fig. 12, this process is called mineralization of metals (Leveille, 2010).

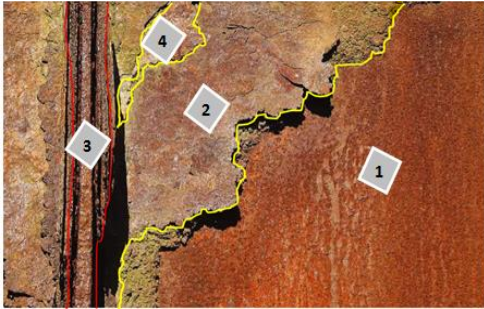
Fig. 13. Types of corrosion in the structure of the lighthouse: 1- Uniform corrosion, 2- irregular Corrosion, 3- Galvanic Corrosion, and 4- Stress Corrosion Cracking (SCC).

- Many erosion types appeared in the ceilings and the body of the houselights, where the iron was subjected to erosion between the granular cells that make up the material (uniform erosion), which is called the corrosion between crystals on the boundaries of the metal grains. (Lyon, 2011). Then the erosion is transformed by careful dissociation of impurities and alloying elements at the grain boundaries (irregular erosion). Then the erosion begins to activate the intergranular corrosion driving force, it is the difference between the electrode potentials of the grain boundaries and the grain itself, which forms a galvanic cell (galvanic erosion) in the presence of an electrode, as in Fig. 13.

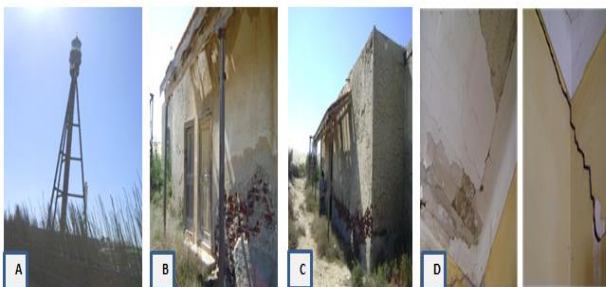
Fig. 14. Many forms of deterioration  
Researcher 2023

- Weak bonds between metal and concrete, causing cracks and collapse in areas at risk, which led to tendencies in the body of the lighthouse and the internal staircase being unsafe as shown in Fig. 14-a.
- The high level of groundwater behind the building, which has a bad effect on the surrounding walls and external walls, as shown in Fig. 14-b.
- The dust road leading to the lighthouse is unpaved and difficult to use, as Fig. 14-c.
- The restoration process was carried out with inappropriate materials and due to many cracks appeared in ceils and walls, as shown in Fig. 14-d.

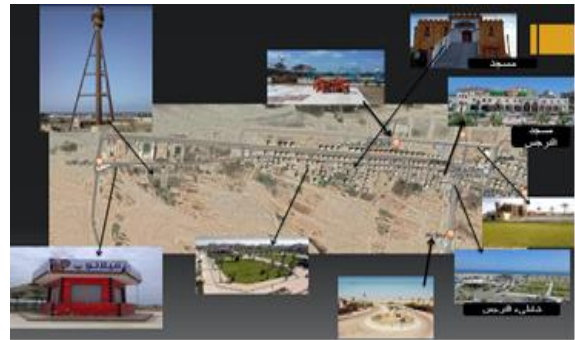
Fig. 15. shows the land use surrounding the house light

- Presence of vacant lands around the lighthouse that can be used as an open space around the building. This provides opportunities to establish many youth camps. There is a Cairo University camp in front of the lighthouse, as Fig. 15.

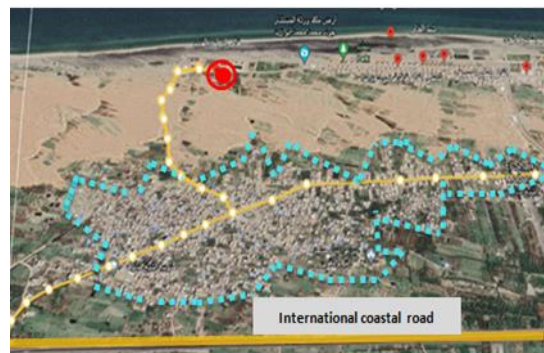
Fig. 16. Creat a connection link between the site of the lighthouse and the village of "Sheikh Mubarak –  
Researcher 2023

- Create an axis linking the international coastal road to the lighthouse and the heart of the village of "Sheikh Mubarak", which can provide the lighthouse with the necessary services and facilitate the movement of its connection with the village services and the transportation of visitors and trips of school children's, as Fig. 16.
